System Test Results from LBL

K. Einsweiler, LBNL

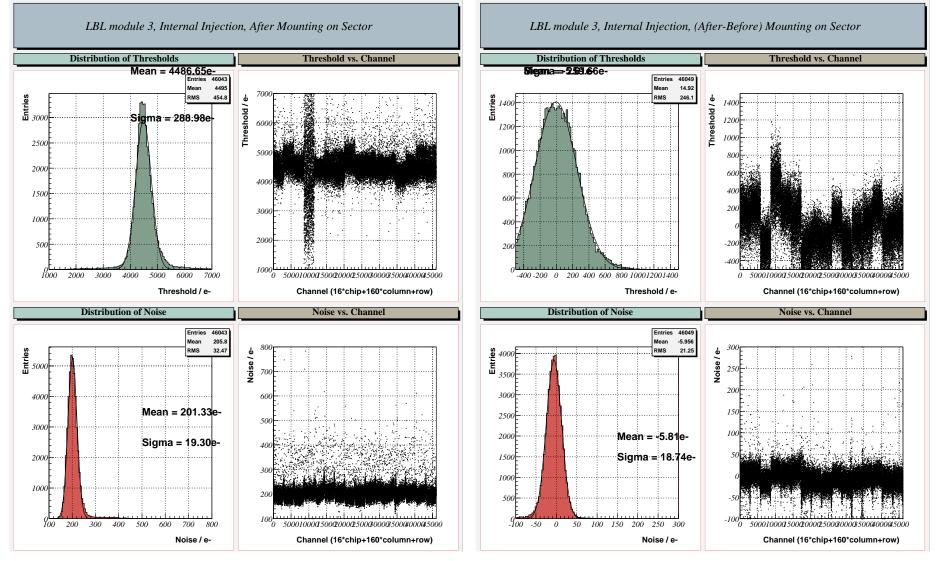
•Compare threshold scans made with single modules in the lab and with modules mounted on sector. LBL_3 shows similar noise, increased dispersion due to ΔT :

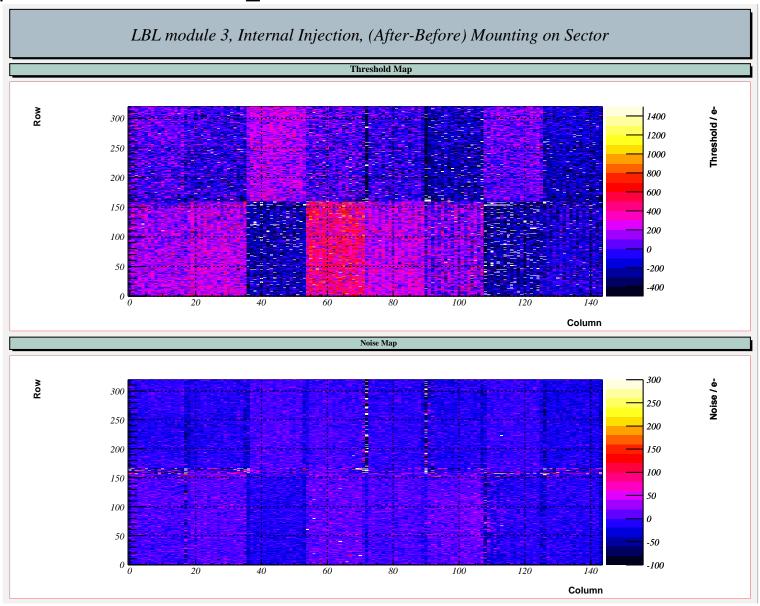
Map of differences for LBL_3:

•Differences seen can mainly be attributed to fact that pre-mount scan was in "AntiKill" mode and post-mount scan was in "Stage" mode.

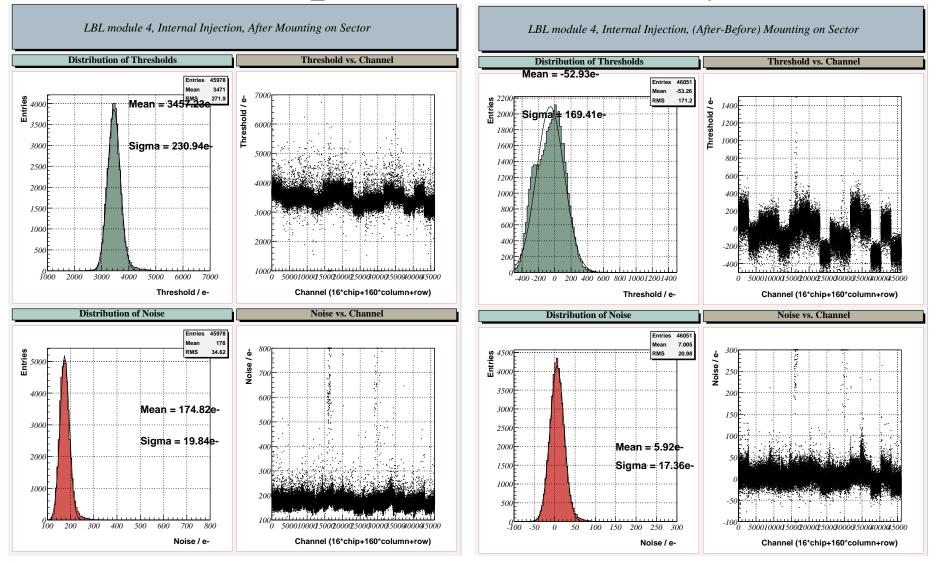
Compare threshold scans made with single modules in the lab and with modules mounted on sector. LBL_4 shows similar noise, increased dispersion due to ΔT :

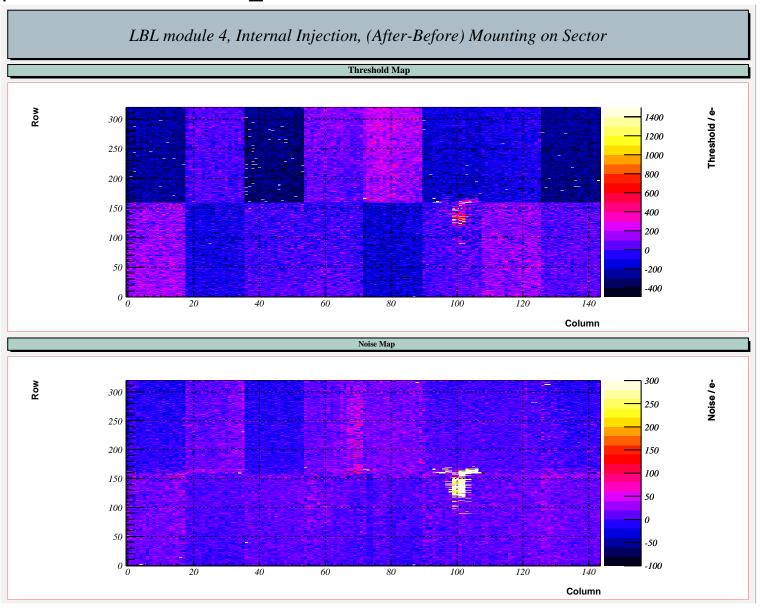
Map of differences for LBL_4:

•Major observation is significant bump damage in chips 5 and 10. Crosstalk scans confirm that there are now a large number of merged or almost merged bumps.

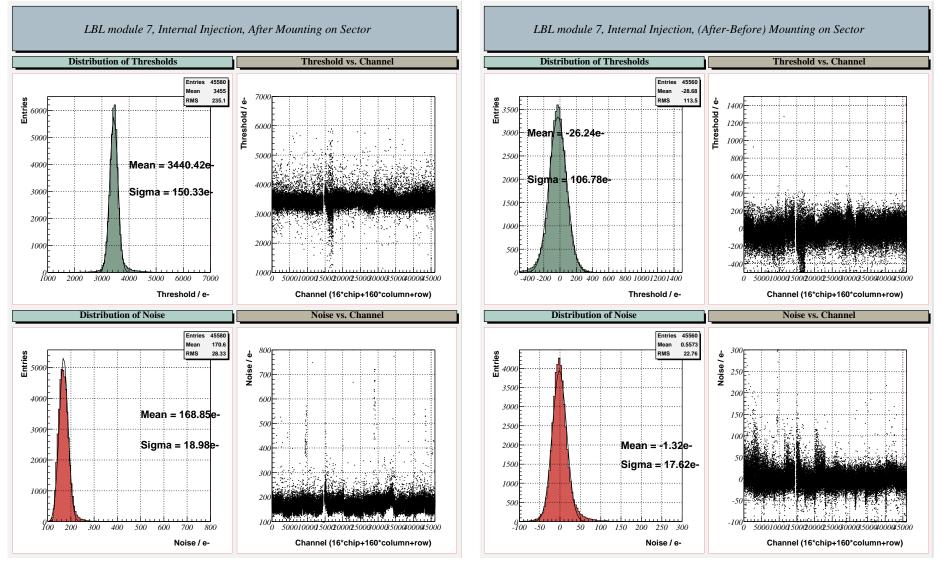
•Compare threshold scans made with single modules in the lab and with modules mounted on sector. LBL_7 shows similar noise, increased dispersion due to ΔT :

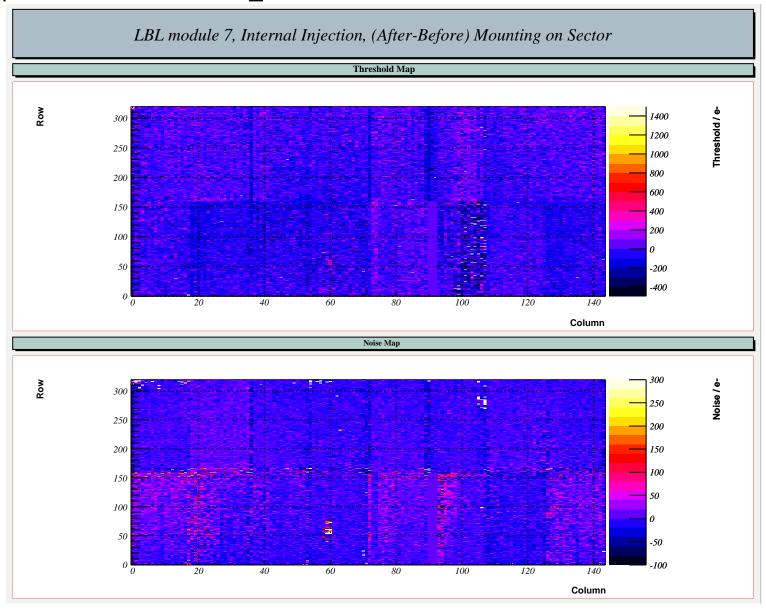
Map of differences for LBL_7:

Major observation is significant bump damage in chip 3. Note chip 10 already showed large region of merged bumps before mounting.

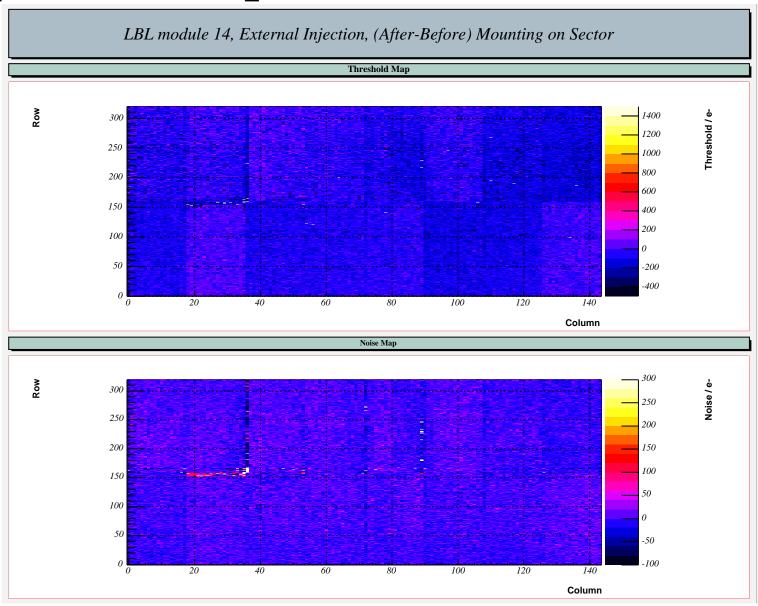
Map of differences for LBL_14:

Only significant shift is in region of chip 1 ganged pixels, which showed very significant merging and poor behavior before mounting on sector.
